**Institute of Paleo-Environment and Heritage Conservation**

**Department of Heritage Management**

HERITAGE MANAGEMENT PRACTICES AND CHALLENGES AT WUKRO  
ARCHAEOLOGICAL MUSEUM AND CHERKOS ROCK-HEWN CHURCH,  
TIGRAY, ETHIOPIA

A Thesis Presented to the Department of Heritage Management, Institute of Paleoenvironment and Heritage Conservation, Mekelle University, in partial fulfillment of the requirements for the Degree of Master of Arts in Heritage Management.

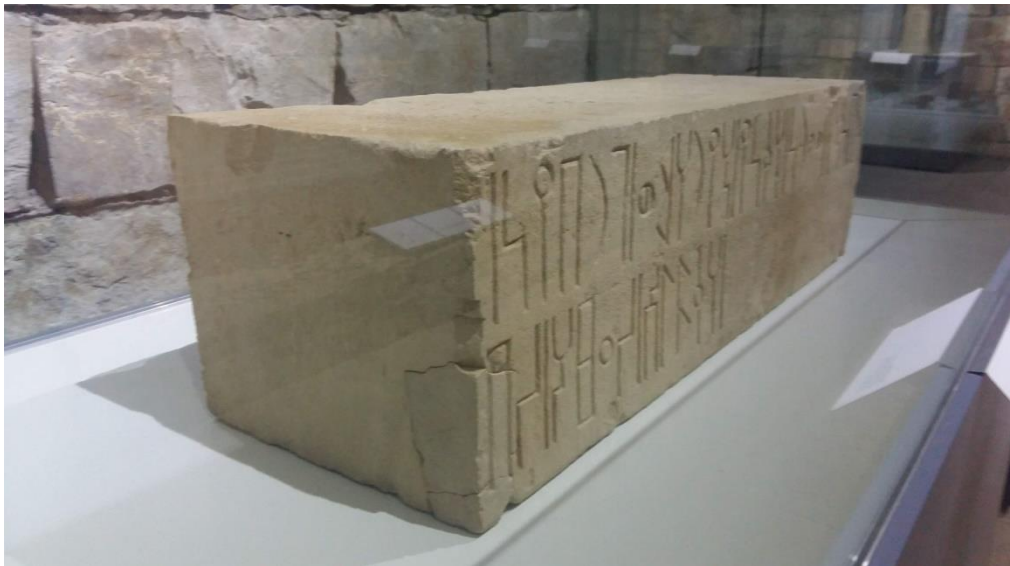
infestation by pests such as insects and rodents, which can cause significant damage to artifacts. There is a need for the Wukro Museum to handle it properly. So that, a training has to be given for the museum staff in proper handling techniques with a view to minimizing physical damage during storage, transportation, and display. Furthermore, using appropriate storage materials, such as acid-free paper and archival-quality boxes, can help to protect artifacts from deterioration. Aside from this, regular monitoring is very important to preserve the Wukro Museum. With this fact, routine inspections of the collection allow for early detection of any signs of damage or deterioration.

Fig.5 image showing protecting case

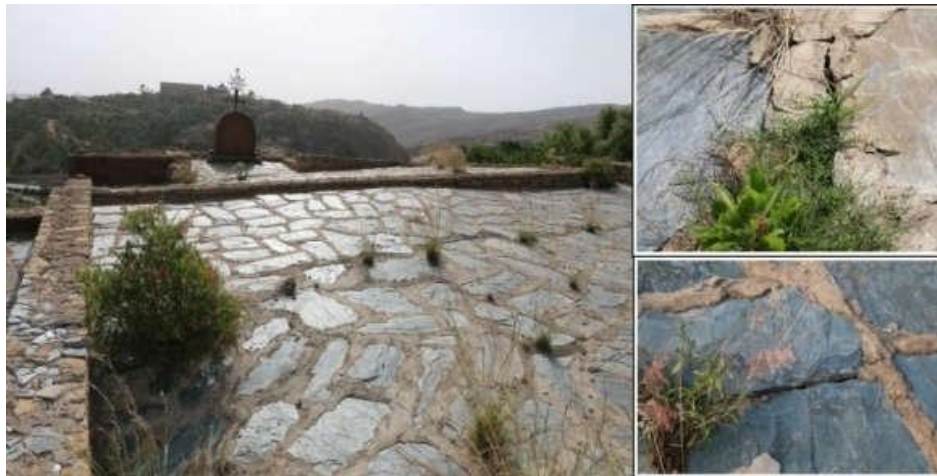
The soil layer was removed in order to relieve the additional weight on the church's structure and monolithic roof. Although it proved to be ineffective, the intervention was thought to be the most practical and easily accessible way to successfully prevent water filtration. The roof fractures that were found and filled with cement concrete were cleared of debris. The roof was then covered with a plastic sheet prior to the flagstones being positioned. Sand and cement concrete

were then used to fill the slate joints. It was supposed to provide the roof with a waterproof surface.

Fig. 6 image showing outcropping grass over the Flagstone roofing

The senior informants clarified that in the past, the rock-hewn churches employed the recreation control mechanism same procedures and strategies for preventing water leaks that are used for the Hudmo II residence in order to manage water infiltration. The informant, who has firsthand expertise, states that there are clear standard procedures for maintaining Hidmo roofs. These procedures involve carefully monitoring the roof's performance both before and after each rainy season and making necessary corrections. Typical corrective actions included: Continuing to fault lines that permit water to flow through; compacting loosening portions and adding an additional layer of carefully chosen soil (every two to three years to replenish the layer lost to wind and rain).

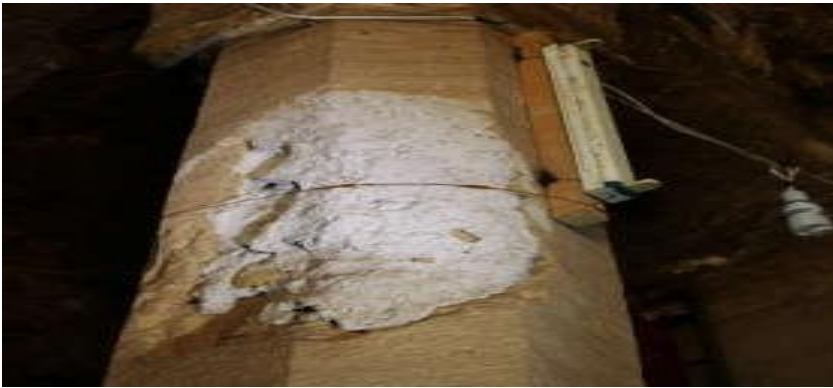
**Challenge one: Flacking and pilling off column layers** Because of its accessibility, the church has been subjected to several uncensored incursions and significant thefts. While it is feasible to determine which portions of the church are original and which are not, it can be challenging to locate documentation

Fig. 7 Image showing damaged altar

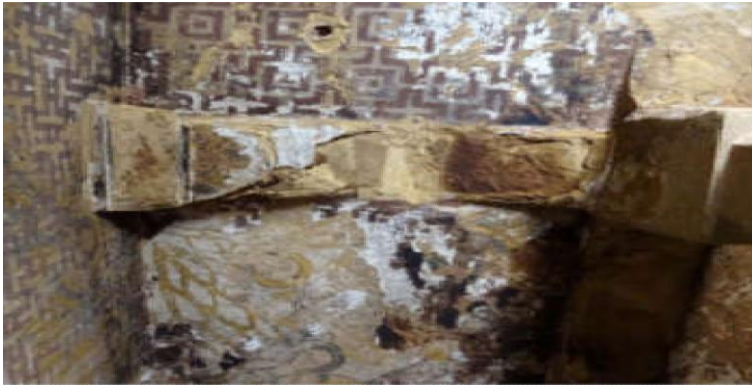
The main and most pressing threat to the church's survival is water leaks. Water damage is occurring to the external and internal walls, as well as to the ceiling reliefs and mural paintings. The ceilings and walls of the southern aisle and sanctuary are severely affected by the spreading and growing mold infestation. There is evidence of dampness across the ceiling, the arches, and the capitals of the monolithic pillars. The head priest emphasized that surface sediments are being swept away and that the water infiltration into the southern sanctuary is creating an environment that is favorable for the agents that cause deterioration to develop.

Fig.8 image showing moldings parts of the building

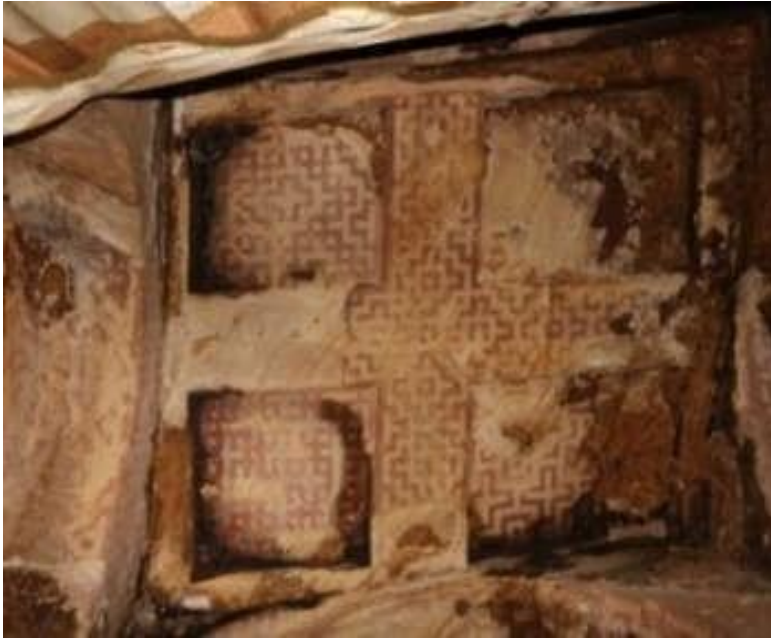
These three issues warranting consideration emerged from the observation and conversations with the clergy: What kind actions were customarily performed to discourage issues associated to water? How long has the water leakage issue been there before it got to this point? And why is the southern sanctuary seeing a more severe water leak? Following is a discussion of each question: Because of this, the southern sanctuary has seen repeated flooding, bushes and micro

plants are growing on the wall and roof, and the ceiling is becoming severely moist. Parts of the ceiling are missing, and the arches are beginning to collapse. These issues are interfering with church services and giving the clergy and disciples distress. (Ephrem Telele W, 2018).

Fig. 9 image showing deteriorating decorated ceiling
