Landslide Susceptibility Mapping Using Frequency Ratio (FR) and Weight of Evidence (WoE) Methods, and Verification Using the Limit Equilibrium (LE) Method: A Case Study along the Bonga - Felegeselam Road.

Submitted to the Department of Earth Science in Partial Fulfillment of the Requirements for the Degree of Master of Science in Geological Engineering

September 2025

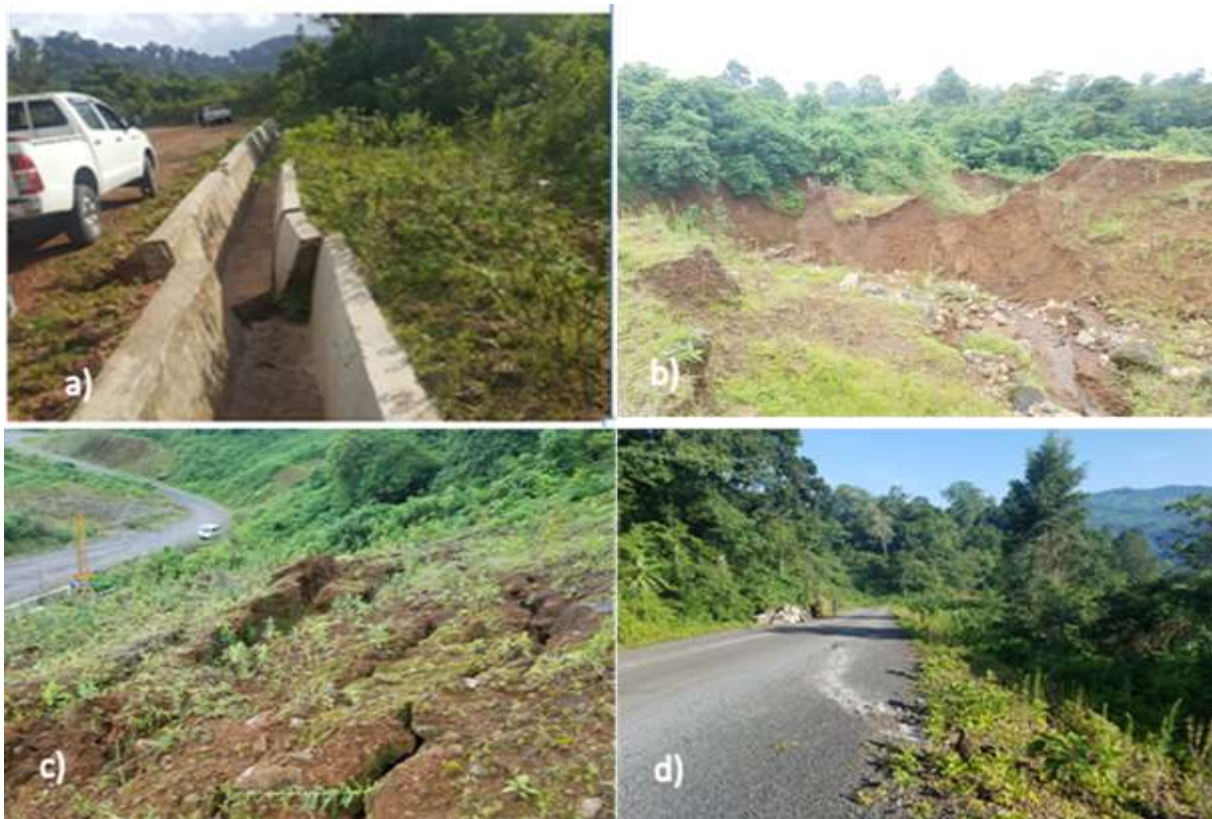
Figure 1: Damage along Bonga–Felegeselam road, showing (a) distorted side ditch, (b) gully erosion, (c) tension cracks, and (d) asphalt differential settlement

Landslides remain one of the key challenges hindering the growth and sustainability of road infrastructure in many parts of Ethiopia highlands. The Bonga-Felegeselam road in southwestern highland Ethiopia has become known for its susceptibility to landslides, due to its steep slope, thick soil deposit, weak bedrock, and the intense seasonal rainfall that beat the region year after year (Ayalew & Yamagishi, 2004; Nyssen et al., 2002; Woldearegay et al., 2004). Currently, many parts of road stretches have been heavily damaged and some entirely blocked due to continuing landslide activity fig. 1 and 2.

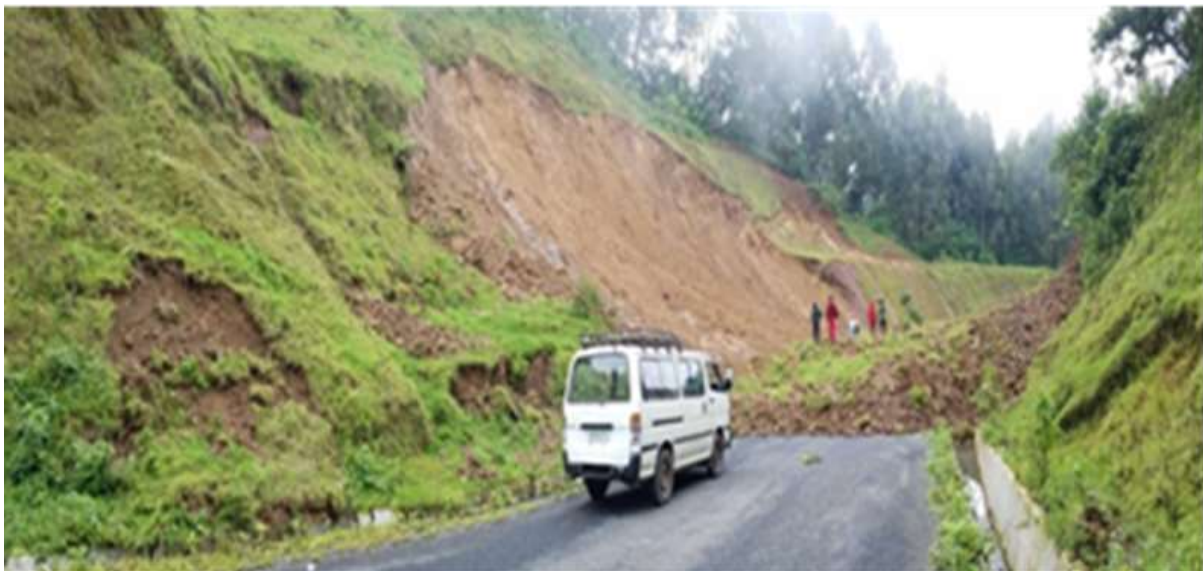
Figure 2: Debris flow blocks Bonga–Felegeselam road near Km 17+340, triggered by heavy rainfall, covering the asphalt.

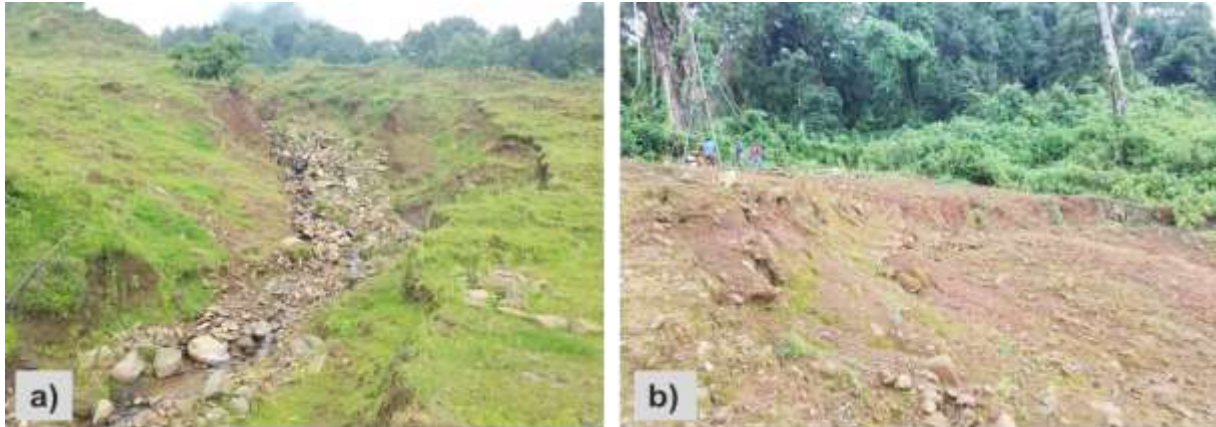
Figure 11: Representative unconsolidated deposits. (a) Alluvial sediments within a riverbed; (b) Colluvial materials along the backslope of a road.

The study area experiences fluctuating rainfall patterns and temperature variations. These conditions, coupled with diverse terrain, complex geological compositions, erosion and weathering processes, promote the formation of unconsolidated deposits. They were formed by weathering of volcanic rocks and undergo erosion then deposited in situ. They moved downhill towards gentler areas, such as valleys, rivers, and streams, driven by the combined forces of gravity and water action. They are distributed throughout the western, central, and eastern parts of the study area (Fig. 11).

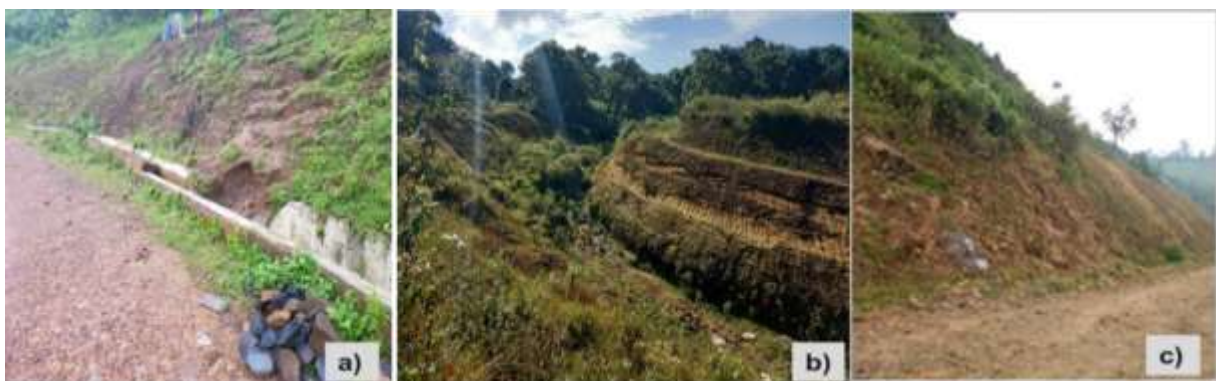
Figure 12: Photographs showing road cut exposures of upper trachyte flows at different locations: (a) completely weathered trachyte at Km 17+000, (b) highly weathered trachyte with deep box cut at Km 51+100, and (c) loose and weathered trachyte exposure with steep slope face at Km 65+500.

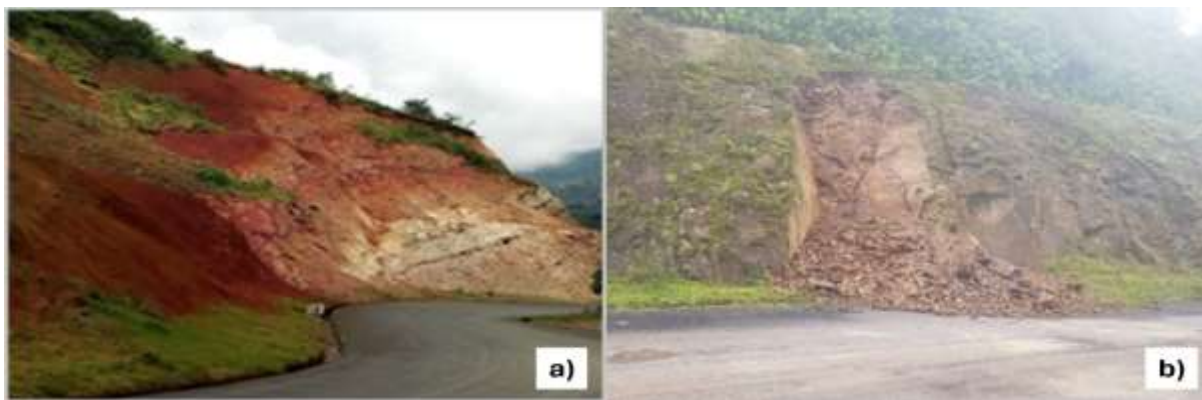
Figure 13: Middle trachyte flow exposures along the road. (a) With distinct paleosol horizon at Km 12+740, indicating ancient weathering surface; (b) Highly jointed and moderately weathered middle trachyte exposure at Km 63+460, showing slope face with potential for instability.

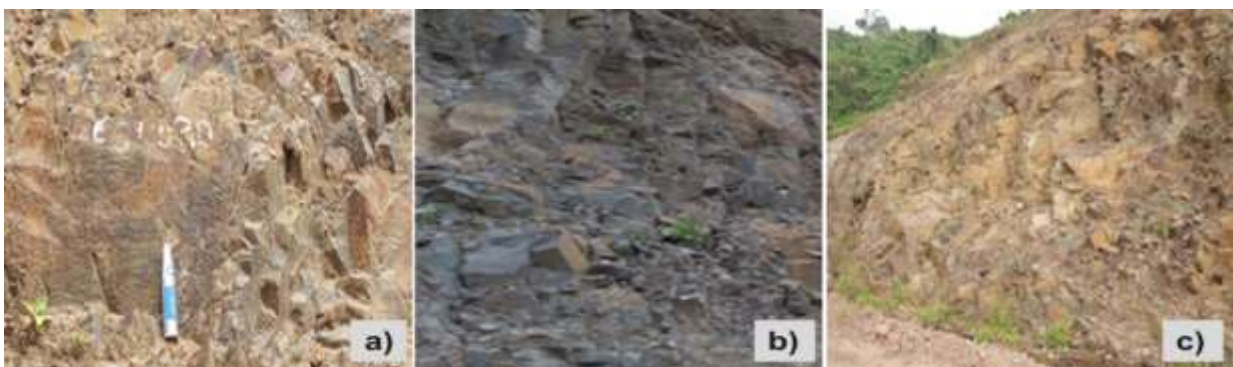
Figure 14: Middle Basalt Flows (TV5) at Km 63+600. Slightly weathered basalt exposure with random jointing observed along the left-hand side of the road.

It is exposed to the extreme southeastern part of the study area, mainly in cut sections of the road (km 63+400-63+800). It is dark gray when fresh and dull gray when weathered. This unit has varied in color in some locations due to weathering, which may affect its strength (Fig. 14).

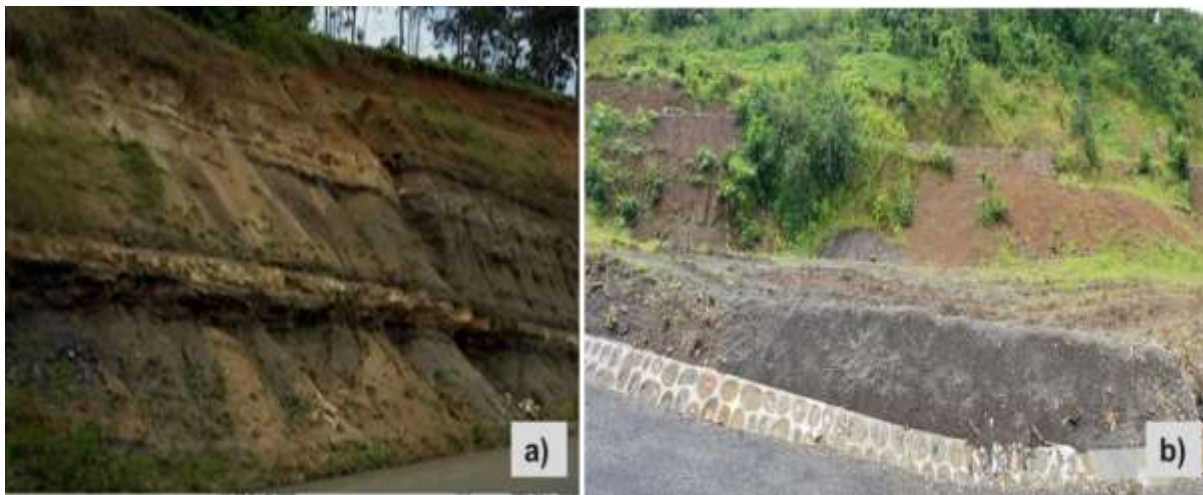
Figure 15: Representative lower trachyte flows. a) Km 31+960: Showing Lower Trachytes exposed around Felegeselam town with visible flow banding and distinct paleosol layers. b) Km 39+480: Highlighting the separation of lower trachyte by paleosol layers and surrounding vegetation.

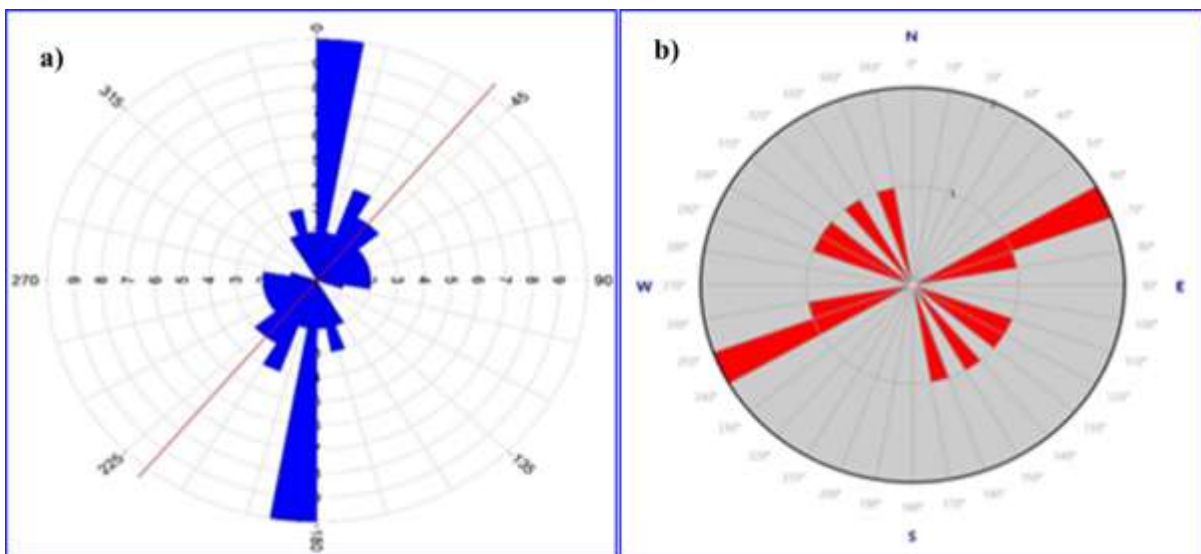
Figure 17: Strike direction of faults (a), and joints (b)

Joints are quite rare in the study area because of the existence of a thick residual and colluvial cover. Three joint sets were observed, however, in road cut sections specifically at Km 57+600 and Km 65+620, while two joint sets were observed at Km 63+400. The joints orientation was usually NNW–SSW for the first, WSW for the second, and SW for the third. These fractures and joints were seen within the trachytic and basaltic rock units, which increase rock permeability. Thus, the occurrence of these fractures and joints is the reason for seasonal contact springs and colluvial seepages in the region.

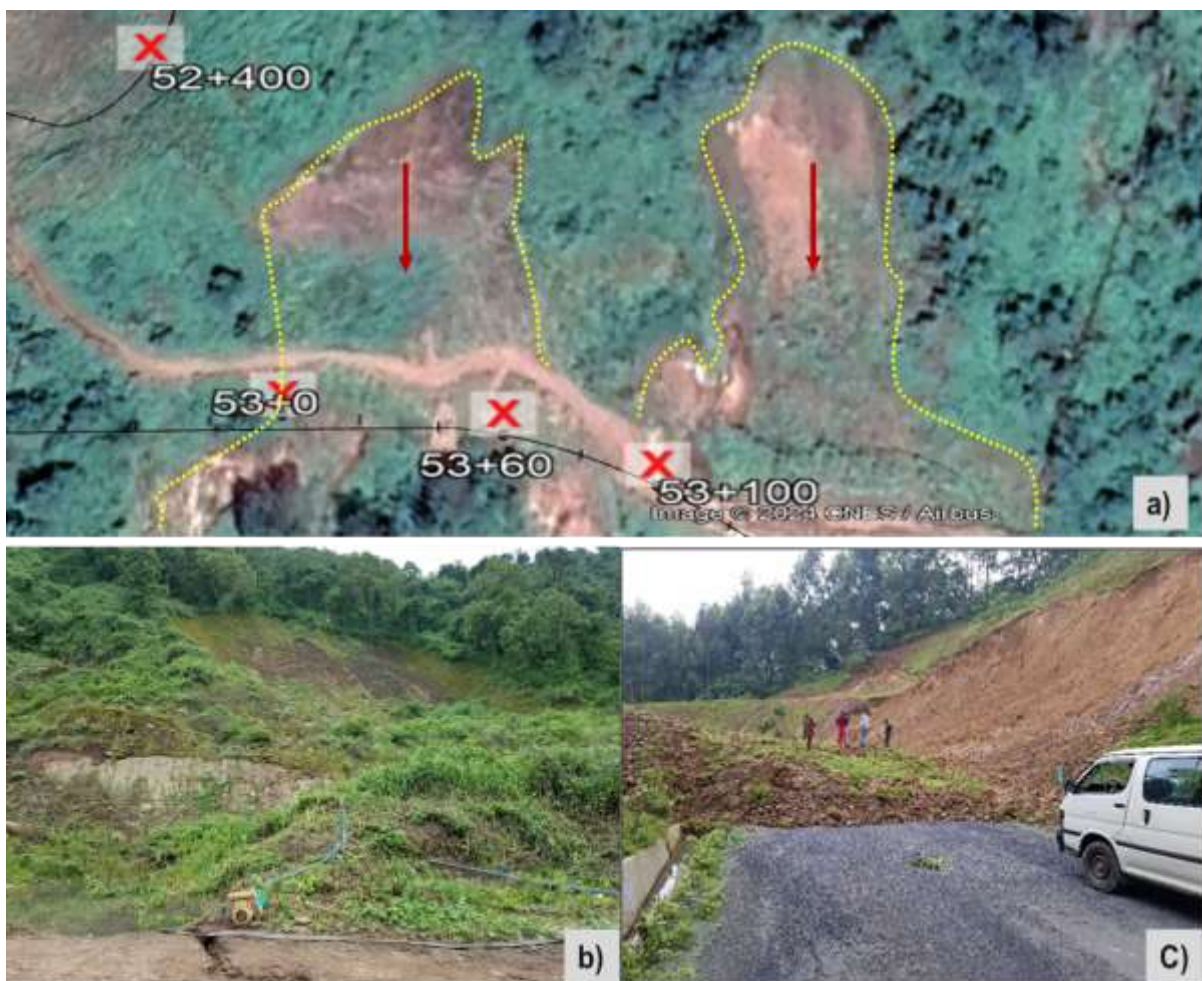
Figure 19: Overview of debris and earth flows from a steep hillside near Migra down to the road. (a) Satellite view from google earth; (b) ground photo showing debris flow paths; and (c) Earth/mud flows along the road cut slope blocking the road (Photographs taken in August 2021).

The primary type of failure identified in the study area is debris /earth flows commonly observed in steep hilly and mountainous areas. From site investigation and observation, the presence of various sizes of rock fragments mixed with fine particles flowing down onto the slope and immediately affected the road. The accumulation of thick colluvium deposits and rock fragments within the slope mass are contributing factors to these debris and earth flows. Indicators of instability in the study area includes road damages, clogged drainage systems, and damaged retaining structures among others and frequently observed in Tari, Migra within forested areas, and Washa localities (Fig. 19).

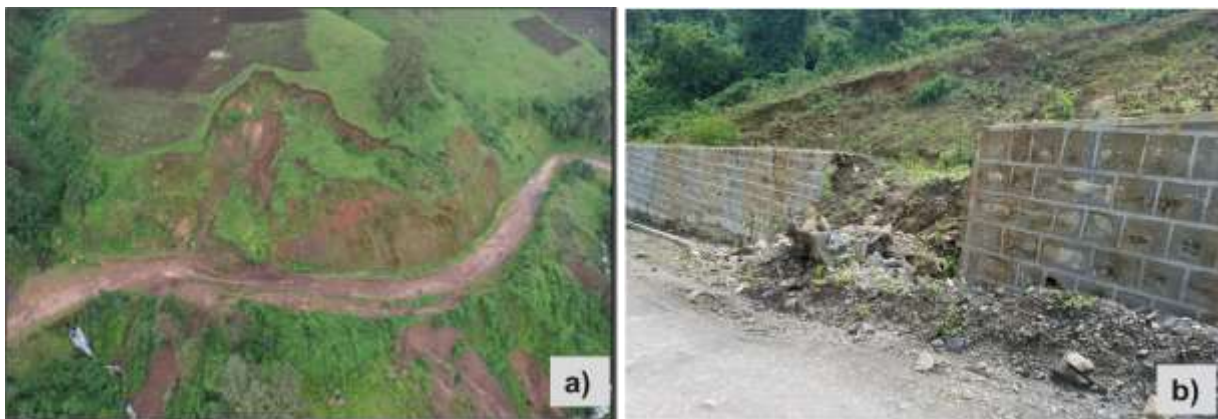
Figure 20: Overview of observed landslides in the study area. (a) general view of rotational landslides, triggered by road cutting, impacting the roadway, (b) additional view of rotational landslide activity, that damaged retaining structure. (Photographs were taken in August 2021).

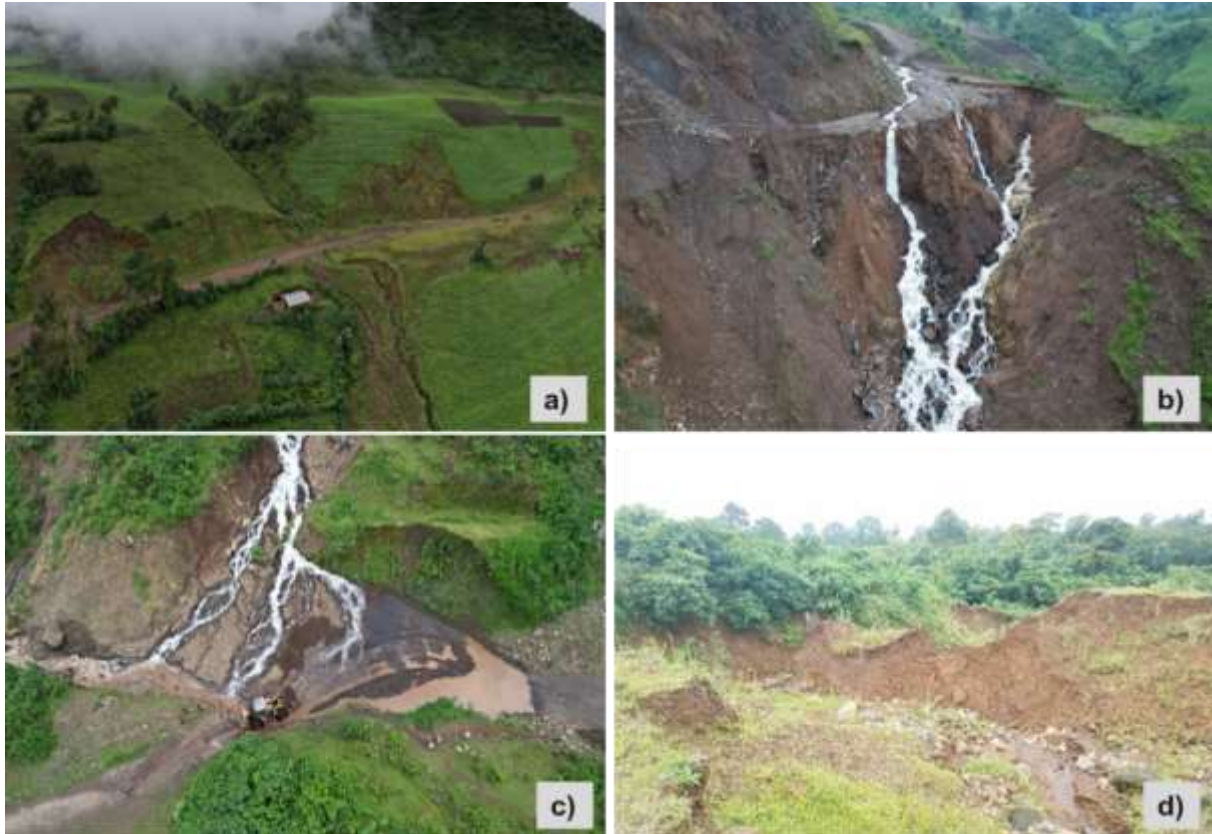
Figure 21: Typical examples of gully erosion. (a) and (b) Gully erosion damaging cultivated areas and causing deep erosion along the roadway near Washa; (c) and (d) widening and scouring around crossing structures near Tari and Mecha. (Photographs were taken in August 2021).

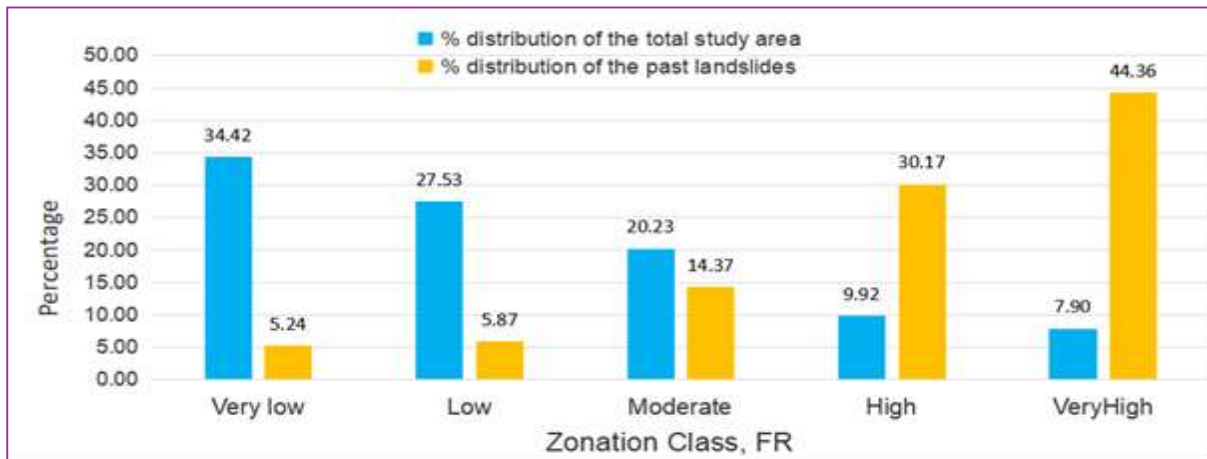
Figure 31: Percentages of areas that represent the different landslide susceptibility zones of the study area using FR

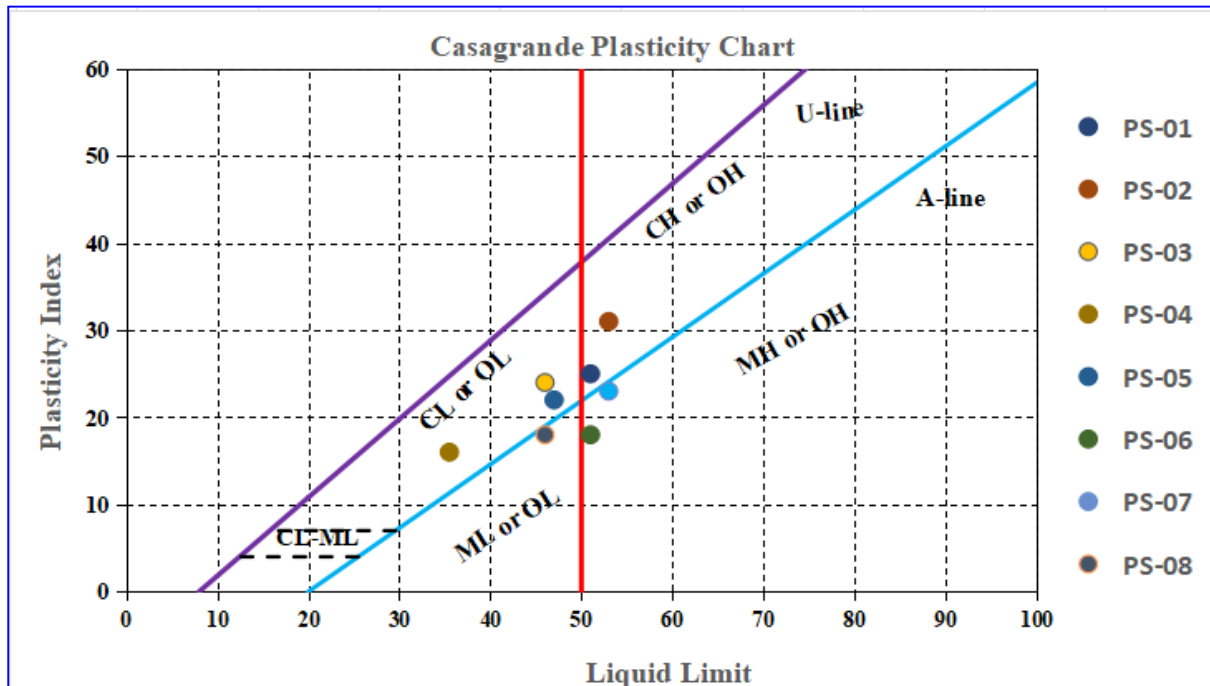
Figure 36: Plasticity chart of soil samples (PS = sample code) from the study area

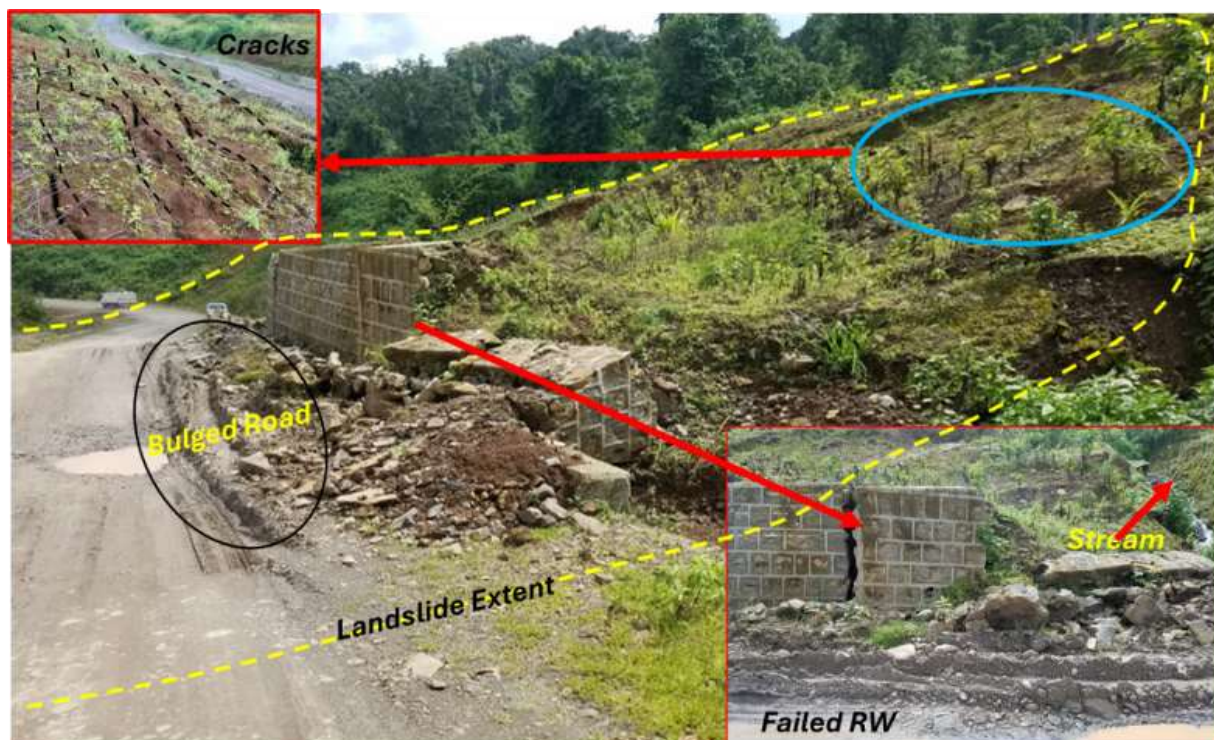
Figure 39: Photo showing failed retaining wall, tension cracks, and bulged road along M1 at Km 20+470, illustrating structural failure and ground deformation (Photo taken in August 2021).

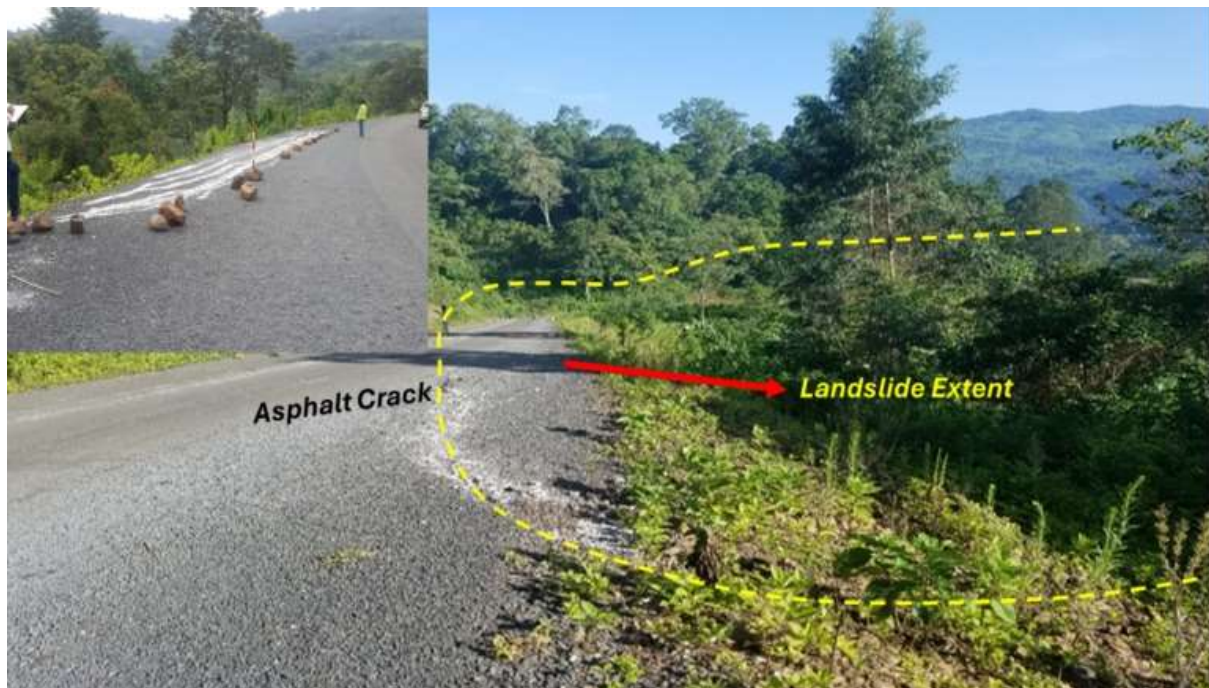
Figure 40: Asphalt settlement over high fill section with longitudinal cracks along M2 at Km 35+220, indicating pavement distress (Photo taken in August 2021).

collapse of the fill material beneath. The fissures and uneven surface create recurring safety issues for road users.

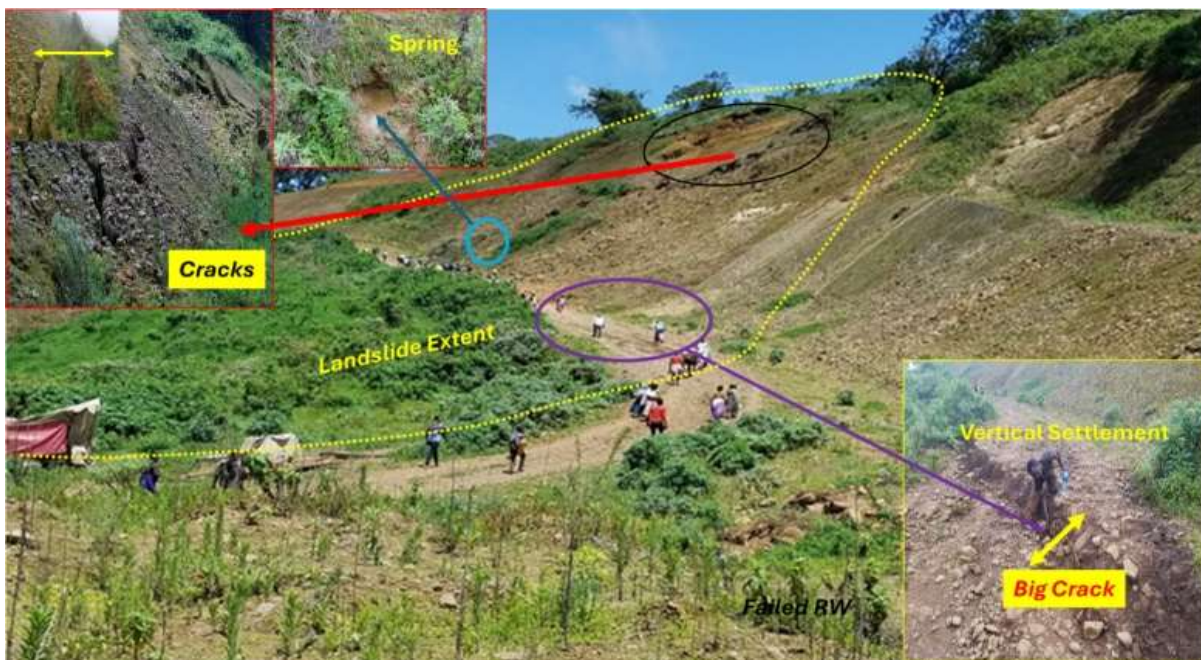
Figure 43: Slope failure with big open cracks on top scarp and springs at slope toe along VH1 at Km 52+200, indicating active landslide with current traffic inaccessibility (Photo taken in August 2021).

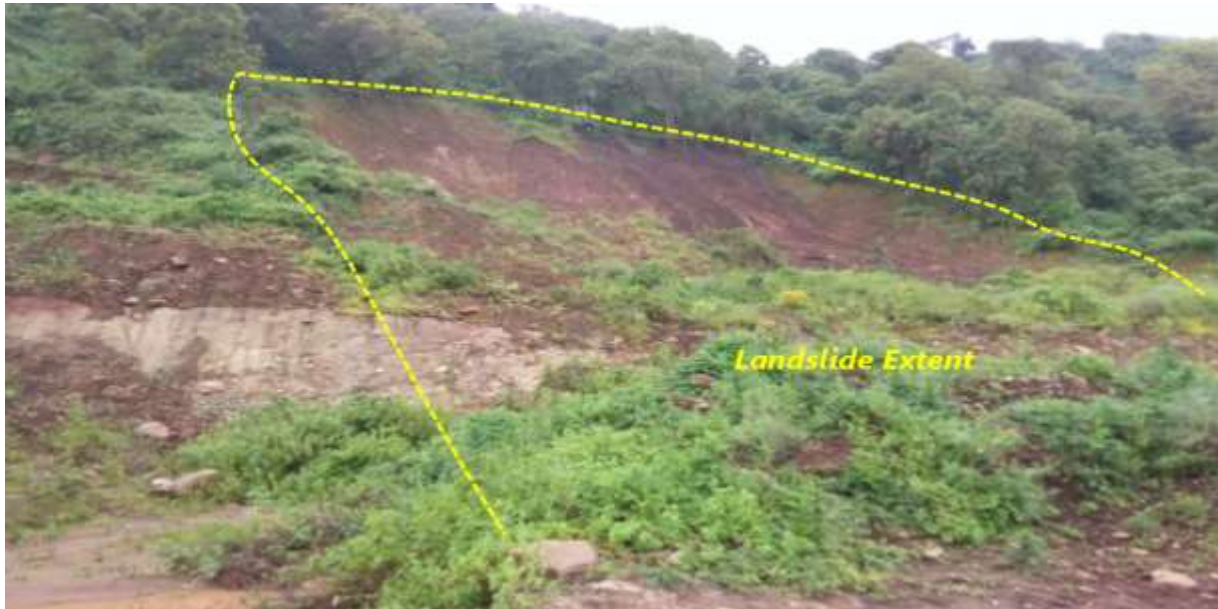
Figure 44: Old debris flow overflowing and cracks on the main scarp along VH2 at Km 53+180, with current road blockage due to active landslide (Photo taken in August, 2021).

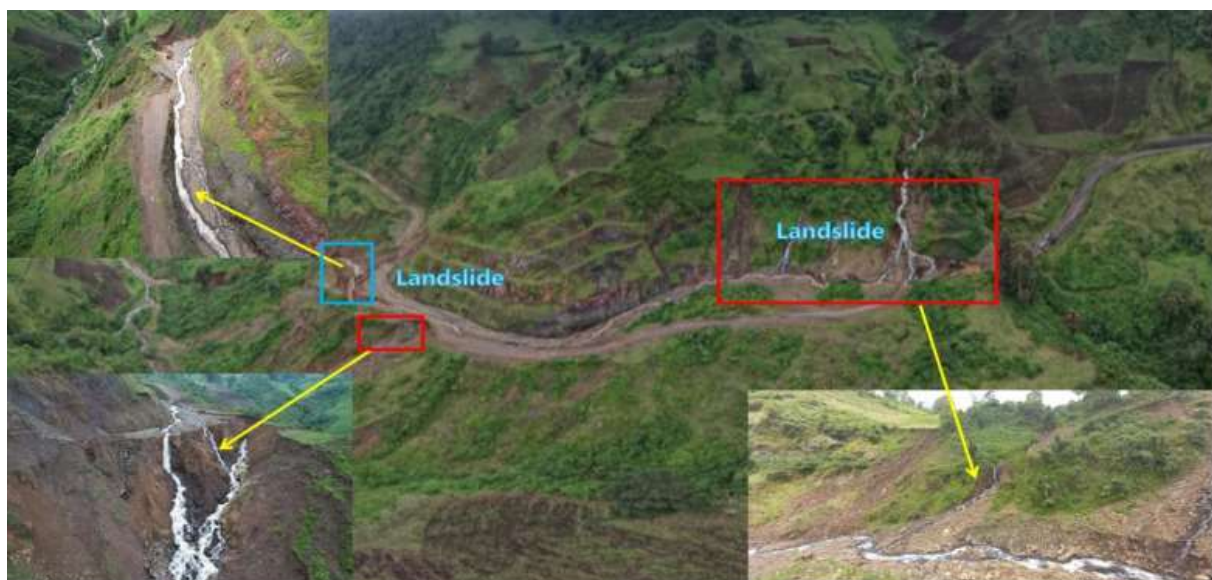
Figure 46: Soil erosion on the face of the back slope and scouring due to roadside erosion and streams along VH4 at Km 65+620, showing significant surface degradation (Photo taken in August 2021).

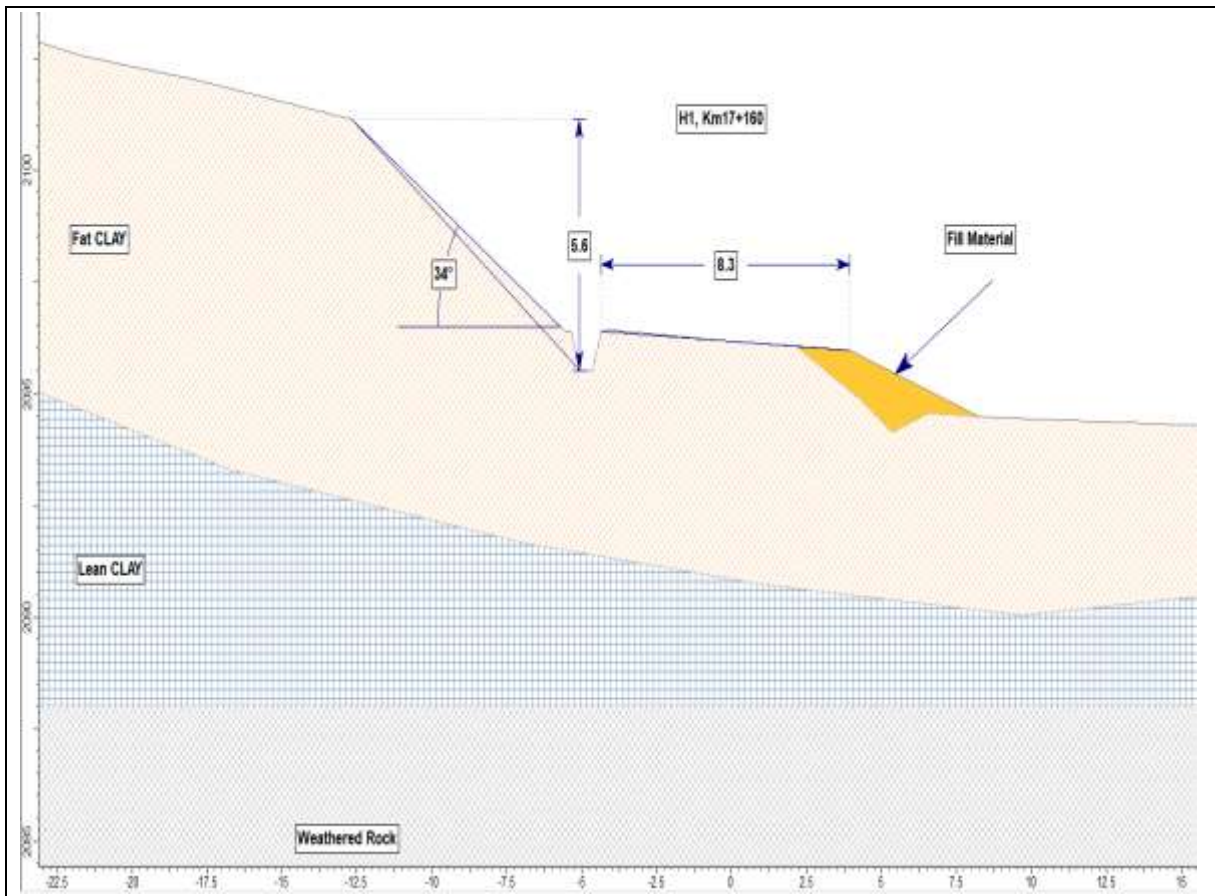
Slope profile at H1, Km17+160

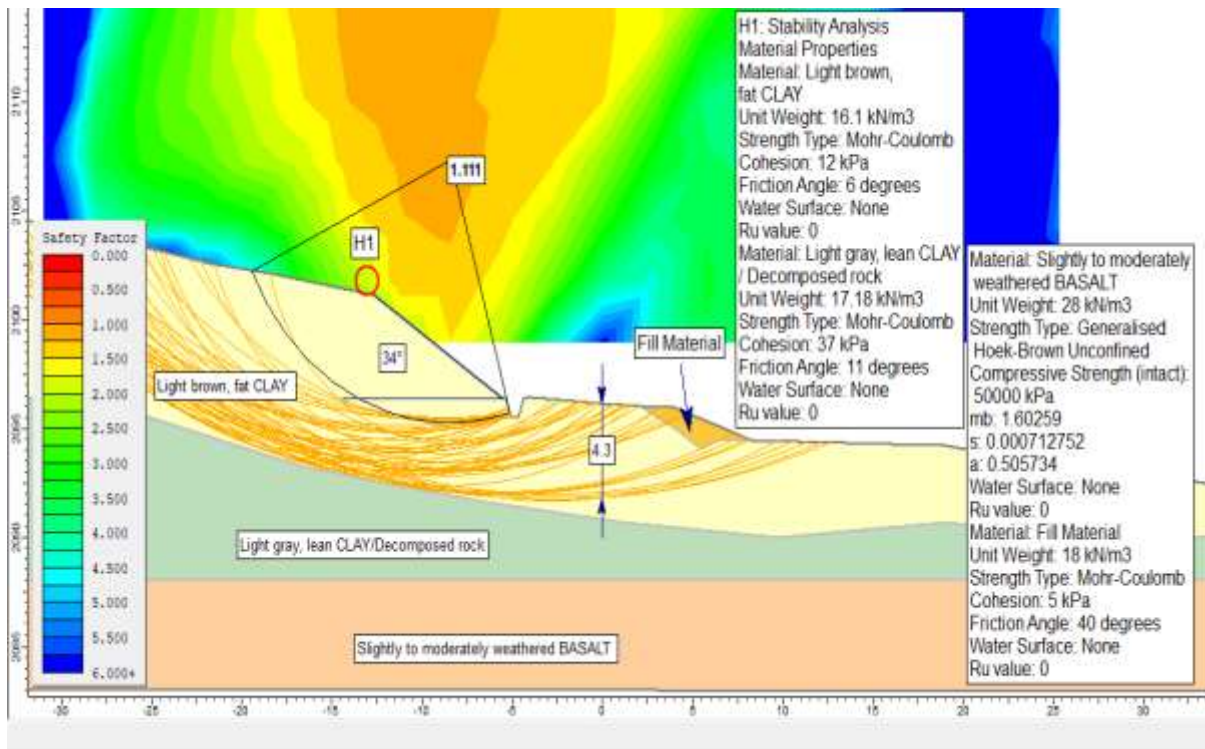
Figure 51: Slope stability analysis outputs of H1 under dry condition (FOS=1.11)

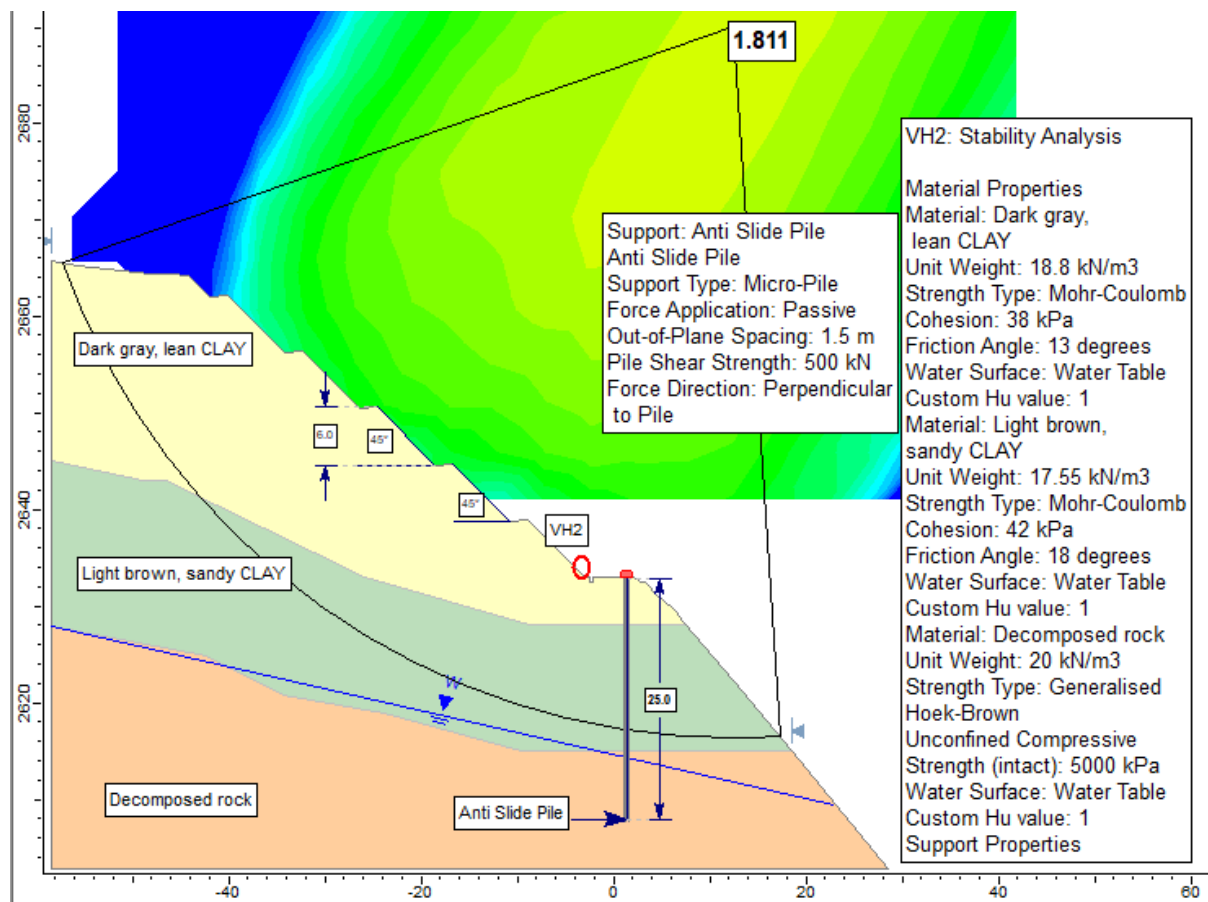
Figure 68: Stability analysis output with remedial measure along VH2, Km53+160
